New York State Department of Transportation

Yellow Flag NB2258W005

BIN: 1065318

Gowanus Expressway
2022 Biennial Inspection - Field Sketch

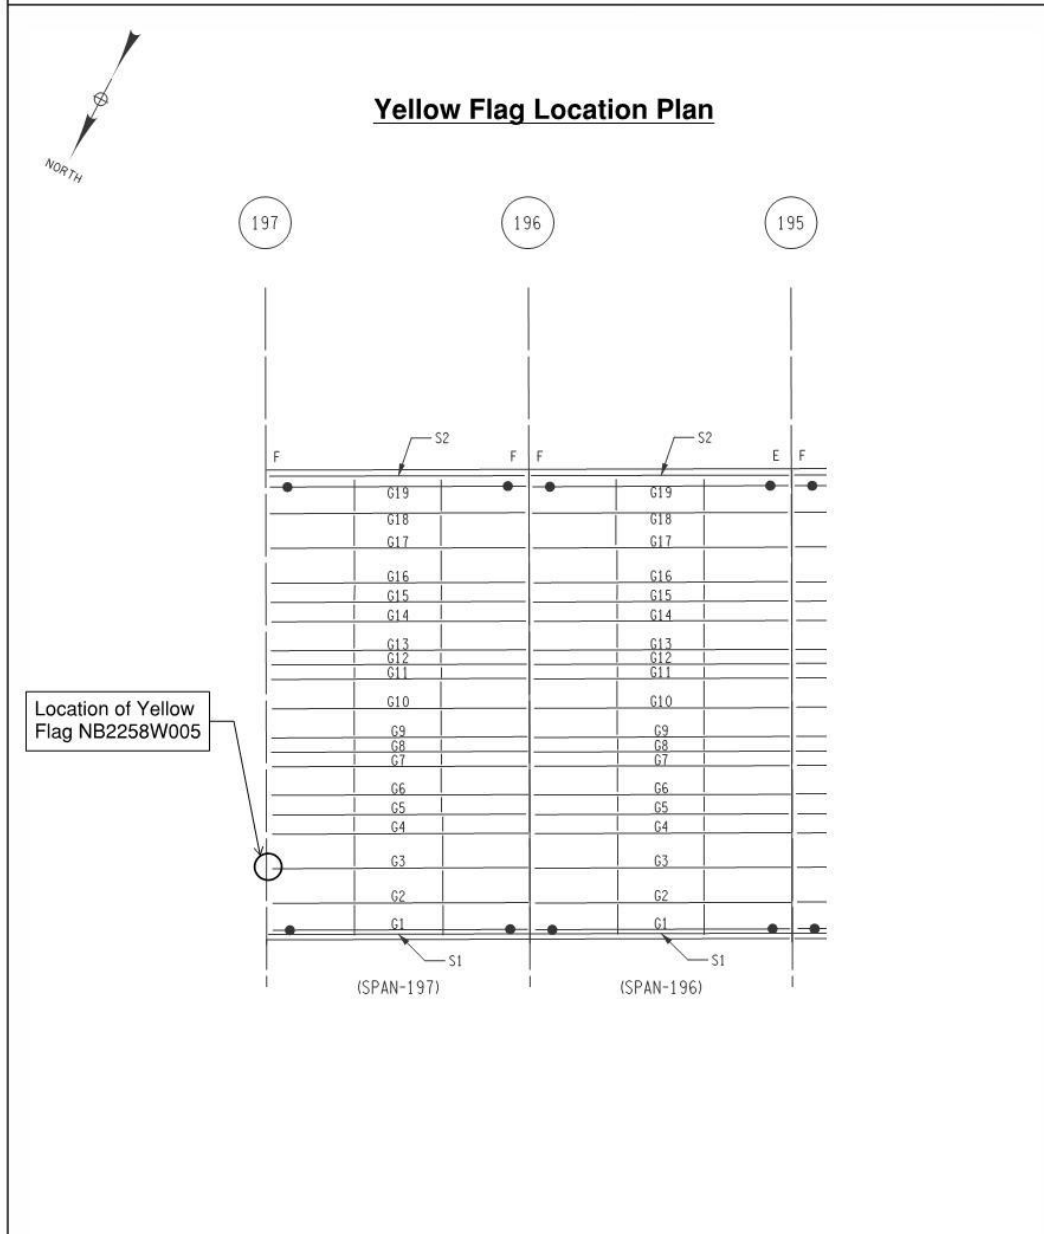
Photo Number: **1**Photo Filename: **22_Flag Location Plan.jpg**

Location: Span 197, Girder G3 at Pier 197 over 3rd Avenue Westbound.

Attachment Description: Yellow Flag Location Plan

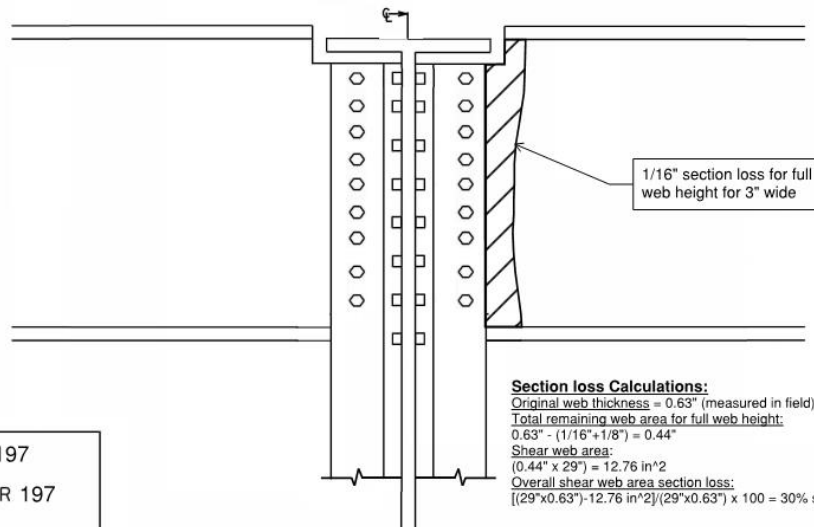
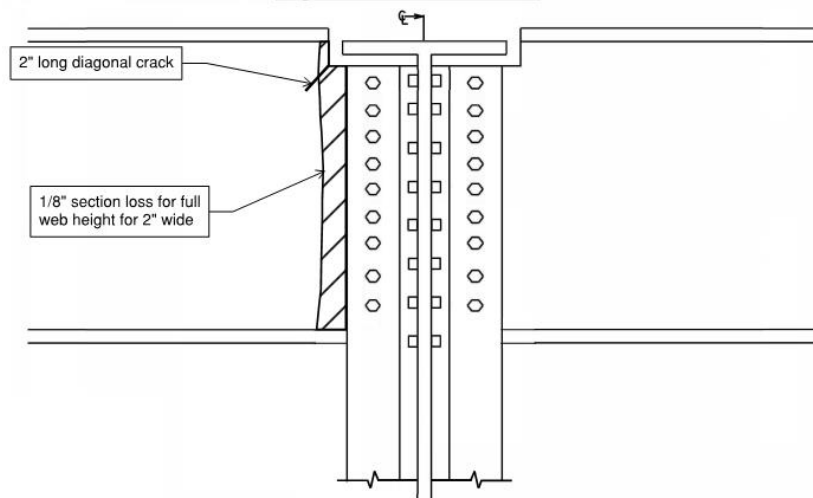
Photo Number: 2

Left Face of Girder G3

SPAN 197
@ PIER 197
G3

Section loss Calculations:

Original web thickness = 0.63" (measured in field)

Total remaining web area for full web height:

$0.63" - (1/16" + 1/8") = 0.44"$

Shear web area:

$(0.44" \times 29") = 12.76 \text{ in}^2$

Overall shear web area section loss:

$[(29" \times 0.63") - 12.76 \text{ in}^2] / (29" \times 0.63") \times 100 = 30\% \text{ section loss}$ **Right Face of Girder G3**

Attachment Description: Yellow Flag Condition Sketch

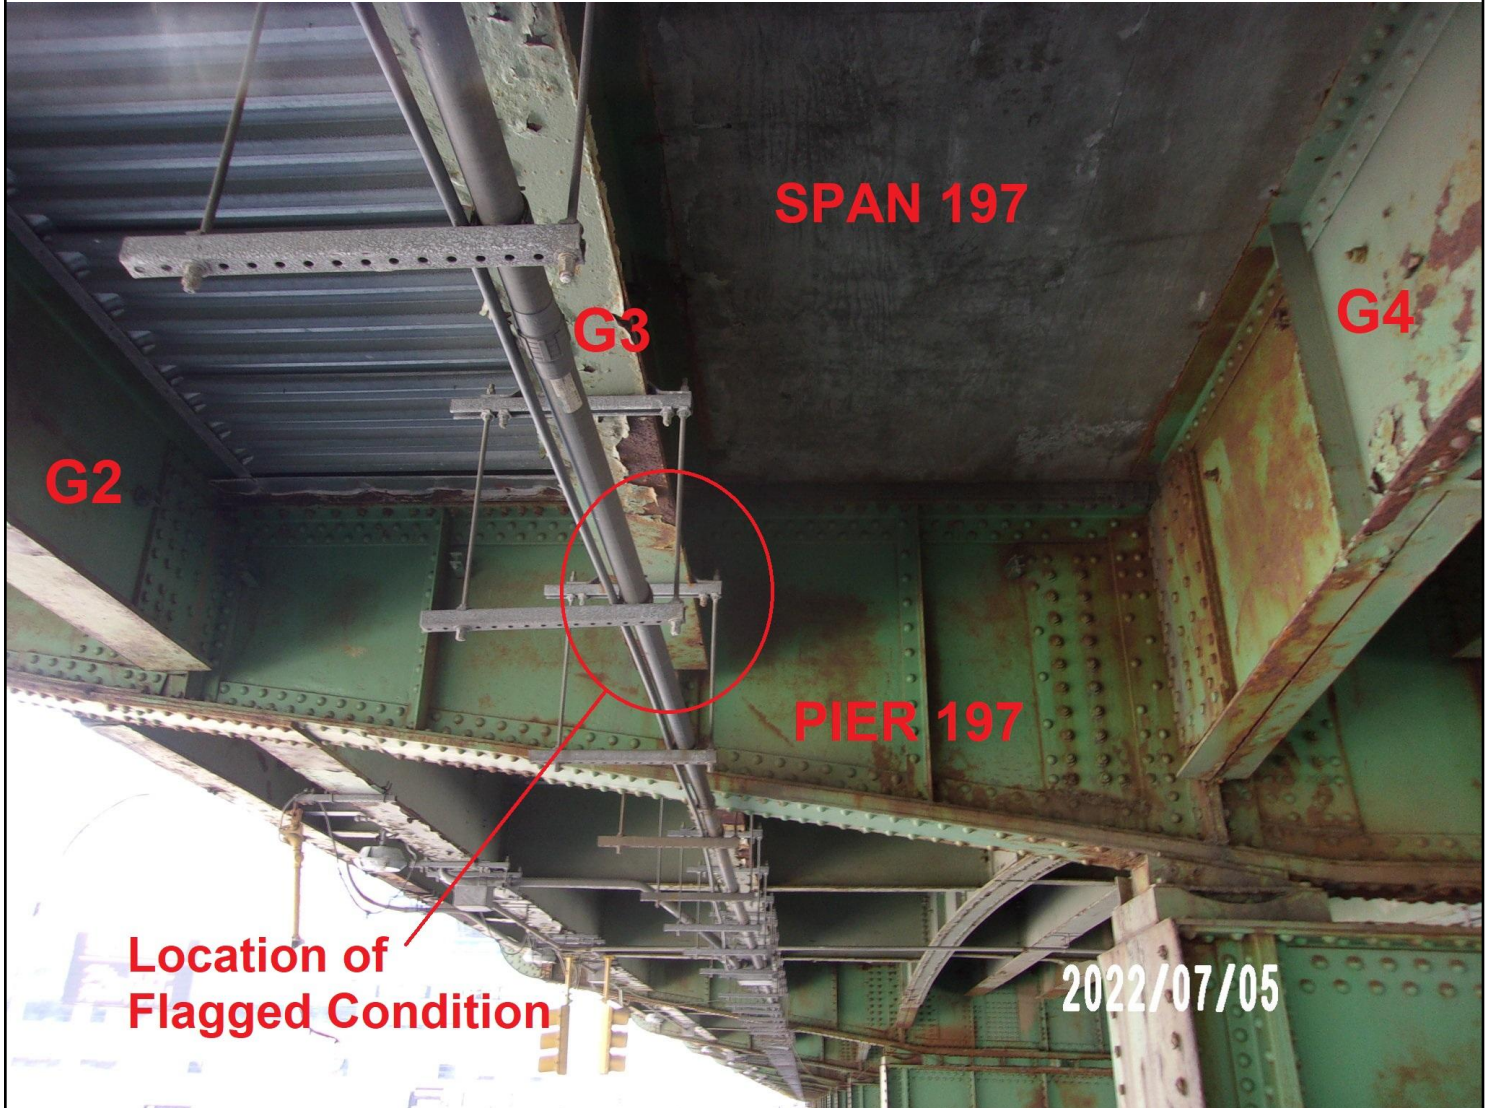
Photo Number: 3

Attachment Description: General view of the flagged condition at Girder G3 in Span 197 at Pier 197. Looking End.

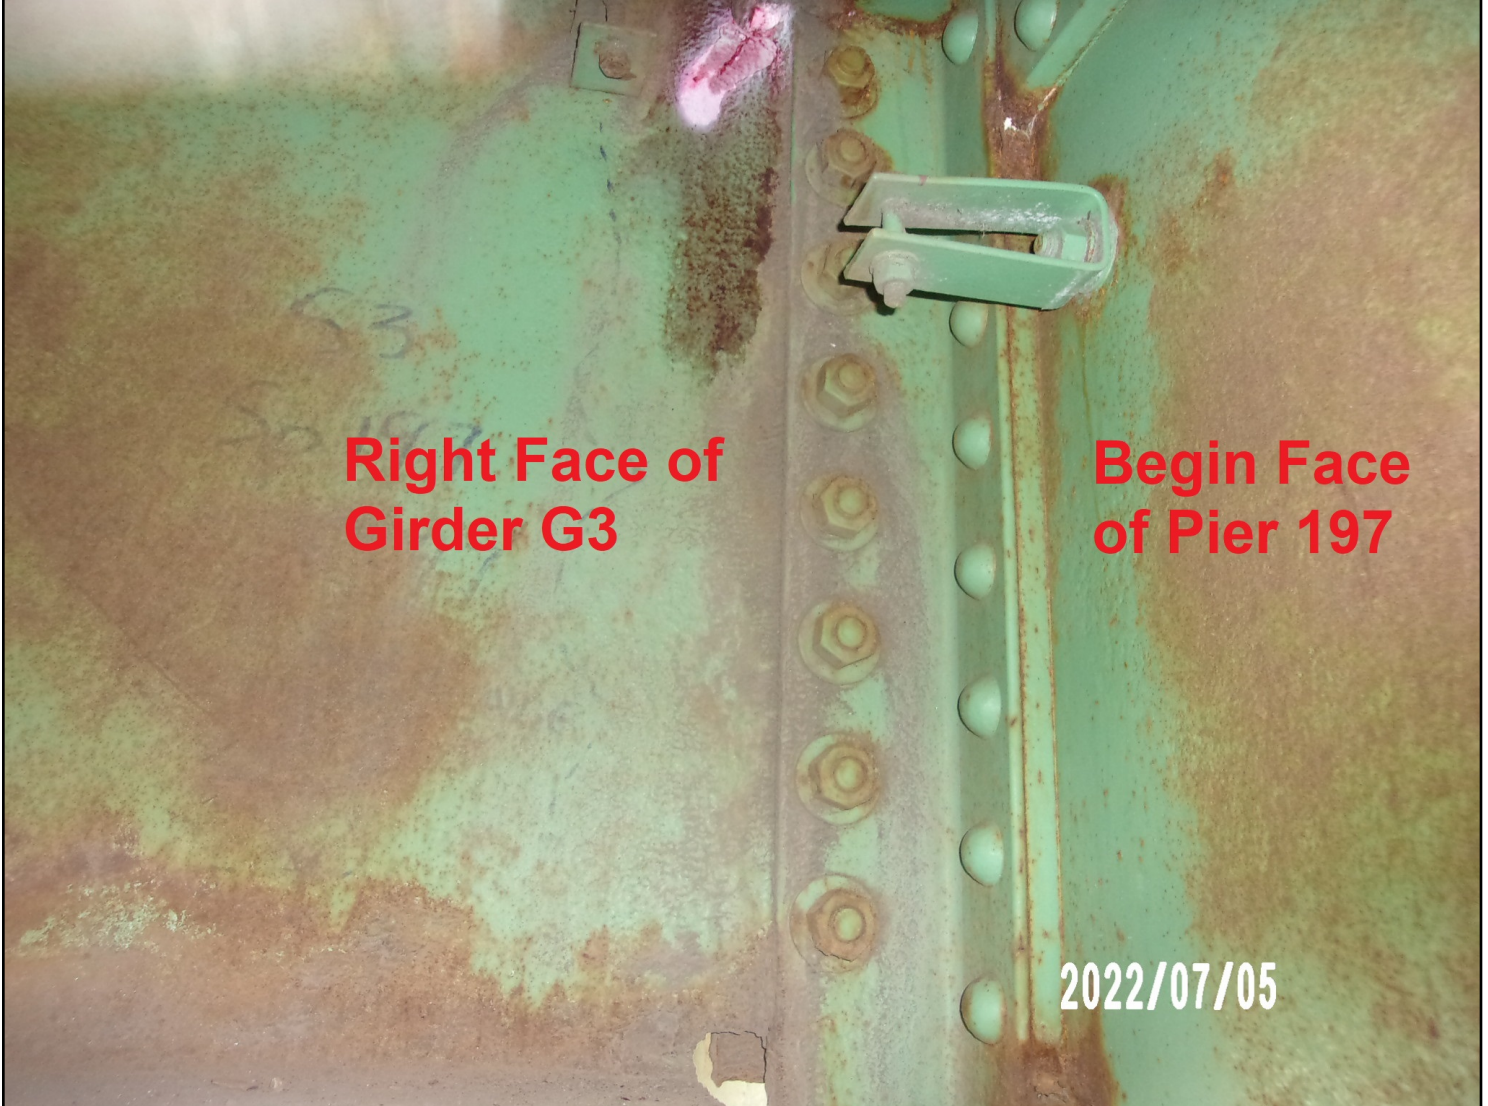
Photo Number: 4

The full height of the girder web along the connection angles exhibits section loss for 1/16" deep for 3" wide at the left face and 1/8" deep for 2" wide at the right face (Photos 4 and 6). The total overall shear web area section loss is approximately 30% for the full height of the girder web. The connection angles at both faces of the girder exhibit no significant defects. Refer to the Yellow Flag Condition Sketch (Photo 2) for more details.

Attachment Description: The right face of Girder G3 in Span 197 at Pier 197. The full height of the web exhibits 1/8" section loss for 2" wide along the connection angle. Looking Left.

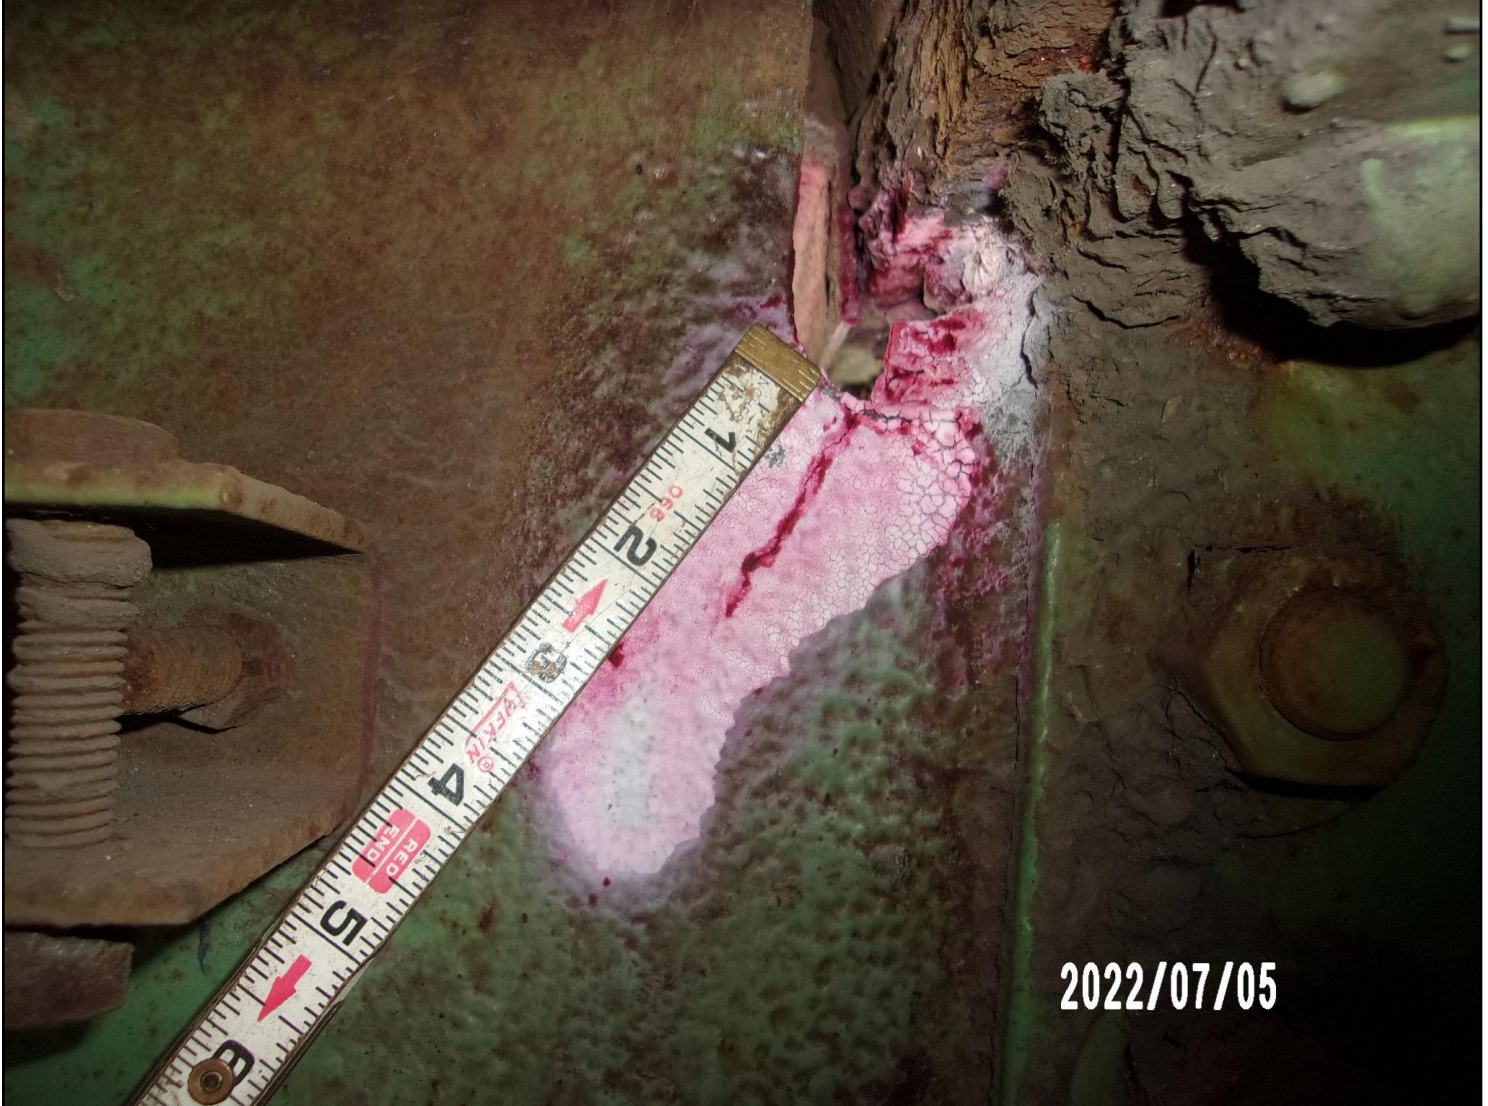
Photo Number: 5

Description: The end of Girder G3 in Span 197 at Pier 197 exhibits a 2" long diagonal crack in the upper web stemming from the top cope at the right face of the girder (Photo 5).

Attachment Description: The right face of Girder G3 in Span 197 at Pier 197. The upper web of the girder exhibits a 2" long diagonal crack stemming from the top cope. Looking Left.

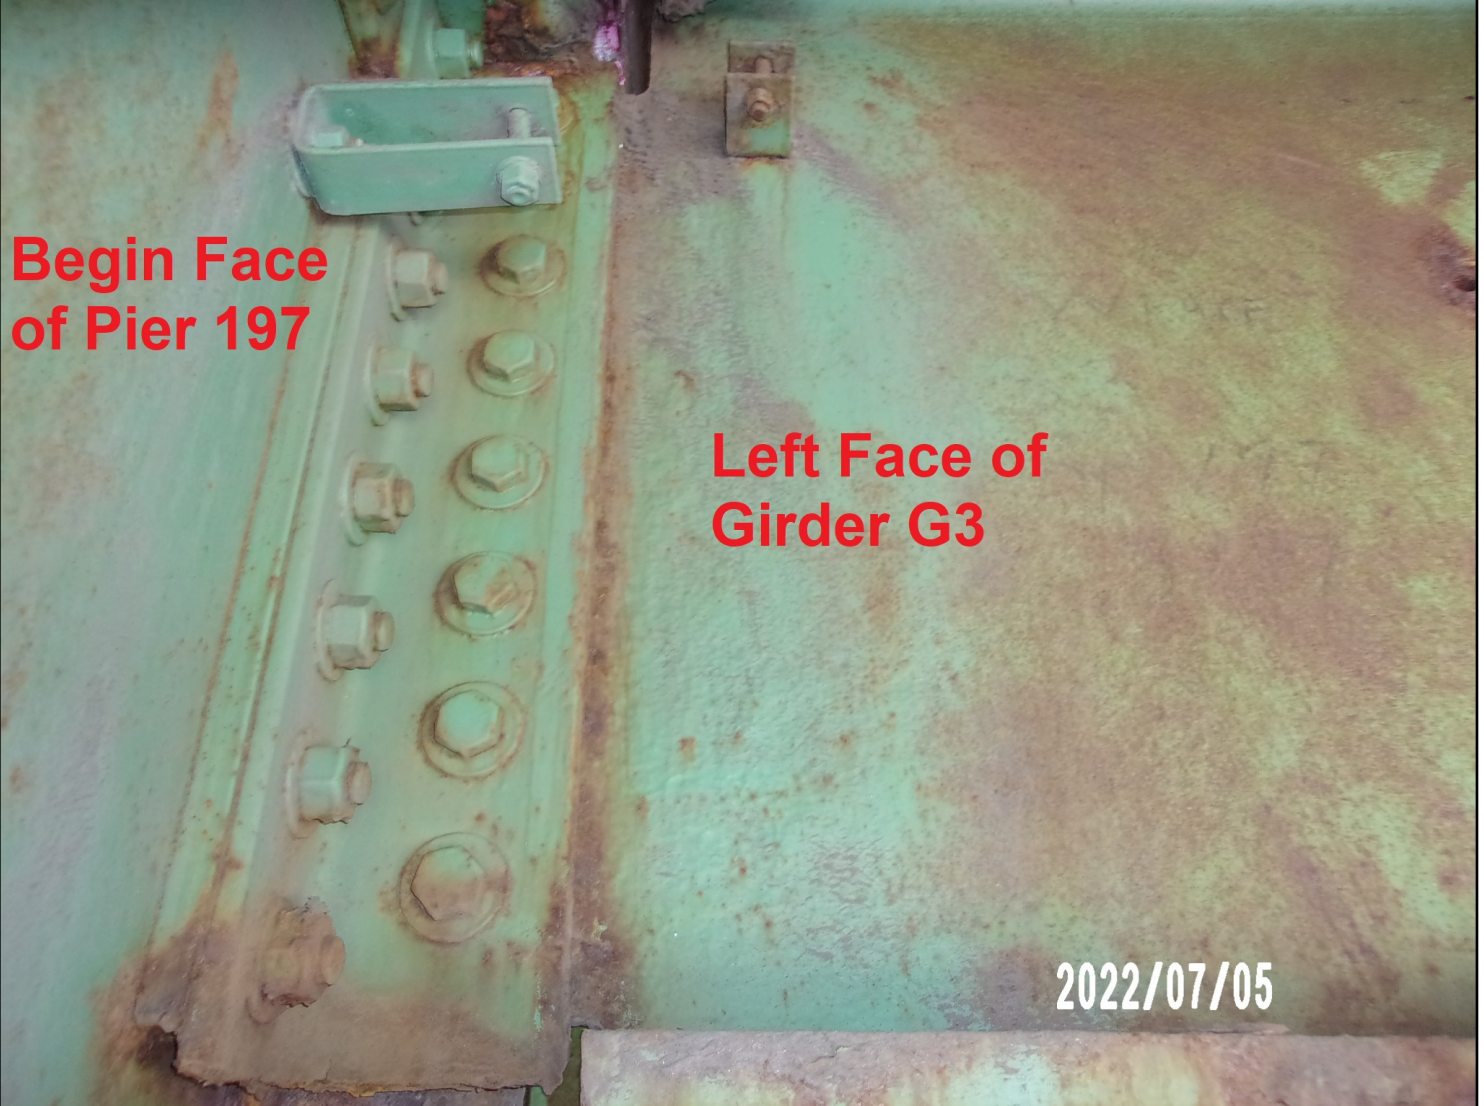
Photo Number: 6

Attachment Description: The left face of Girder G3 in Span 197 at Pier 197. The full height of the web exhibits 1/16" section loss for 3" wide along the connection angle. Looking Right.
